# Manhole Inspection Summary

Manhole # S53Q\_\_012MH

Insp Date: **9/5/08 2:02 PM**

**Location** Address: **1300 s ellwood ave**

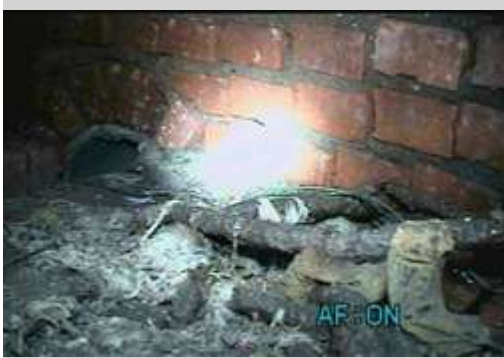
Defect 3

Condition: ☐ Sound ☐ Cracked ☐ Root Intrusion ☐ Deteriorated ☐ Leaks ☒ **Debris**

bench debris

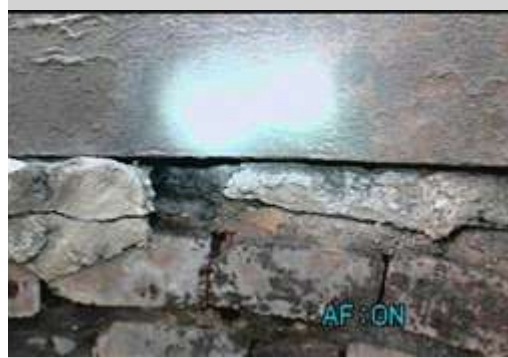
Defect 2

Condition: ☐ Sound ☐ Cracked ☐ Root Intrusion ☒ **Loose Brick** ☒ **Deteriorated**

chimney loose bricks, deteriorated frame adj

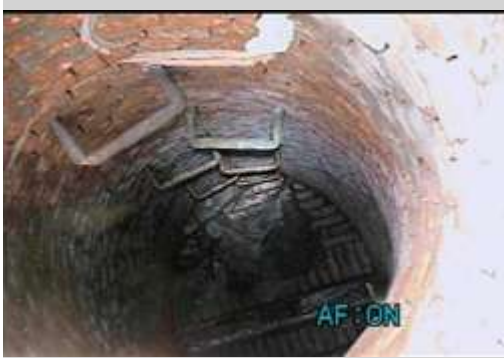
Defect 1

**Steps** Count: **7** Missing: **1** ☒ **Corroded**

missing & corroded steps

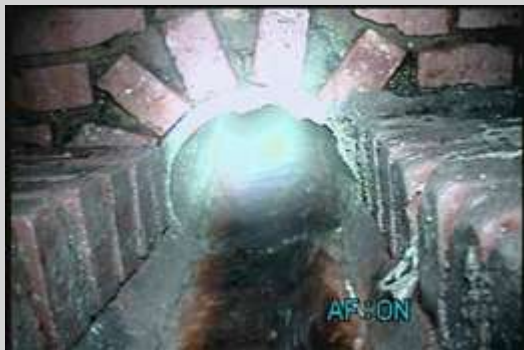
12 O'Clock Outflow

8 in. Circular Gravity Sewer  
Pipe Out @ 12 OClock

Invert Depth: 12.16 (ft.) Flow Characteristics: Fast

Deposits: ☒ None ☐ Mud ☐ Sludge ☐ Debris ☐ Grease

Infiltration: None Pipe Seal Cond: Unknown

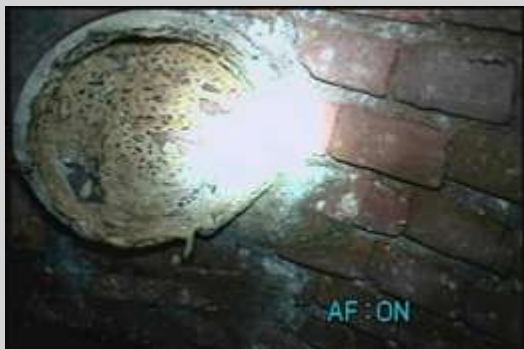
6 O'Clock Inflow

8 in. Circular Gravity Sewer  
Pipe In @ 6 OClock

Drop In @ 6 OClock

Invert Depth: 8.58 (ft.) Flow Characteristics: None

Drop: Outside Direct

Drop Condition: Open
